## Florida State University — Engineering

Please find below photos of the Vulcan Descaler installed in the Florida State University College of Engineering.

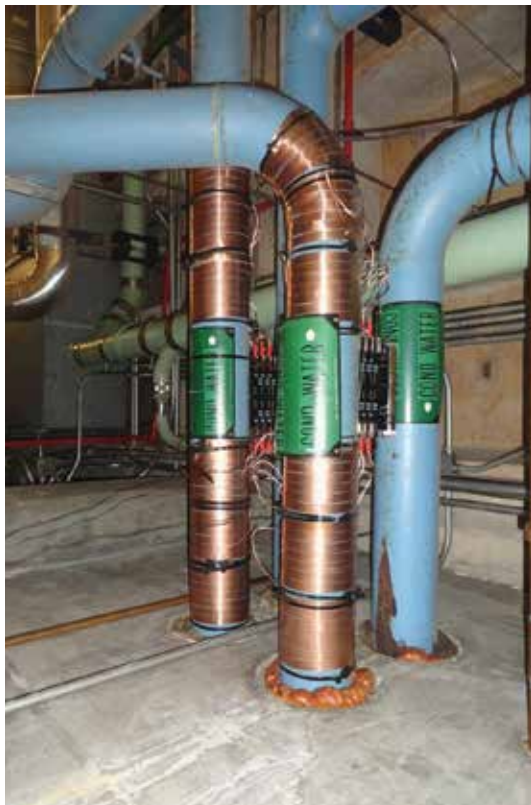
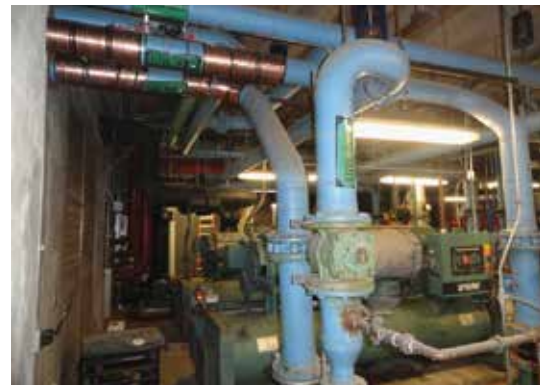
Vulcan S100 units installed on the double chiller

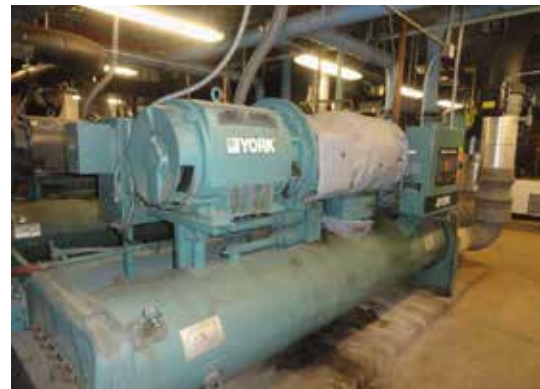
Vulcan units protecting chiller pumps from scale and rust

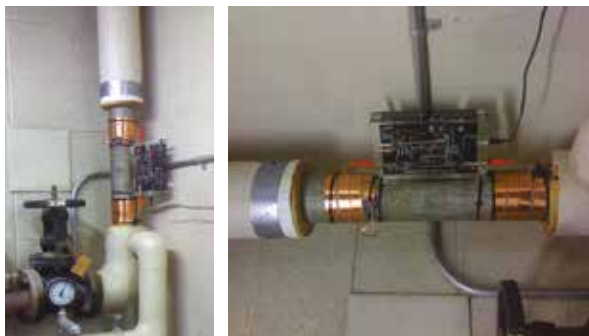
Installation of Vulcan Descaler for the entire building's water supply in the Roosevelt school

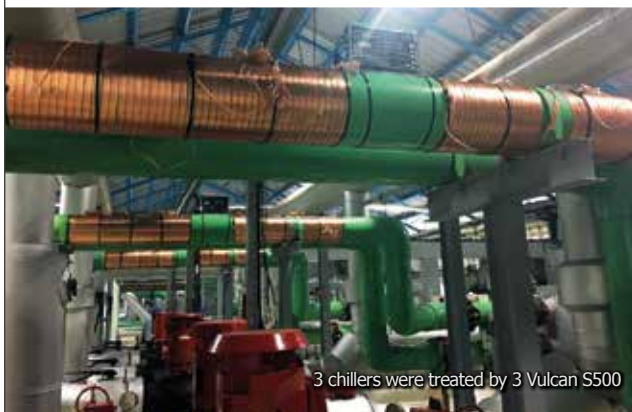
3 chillers were treated by 3 Vulcan S500

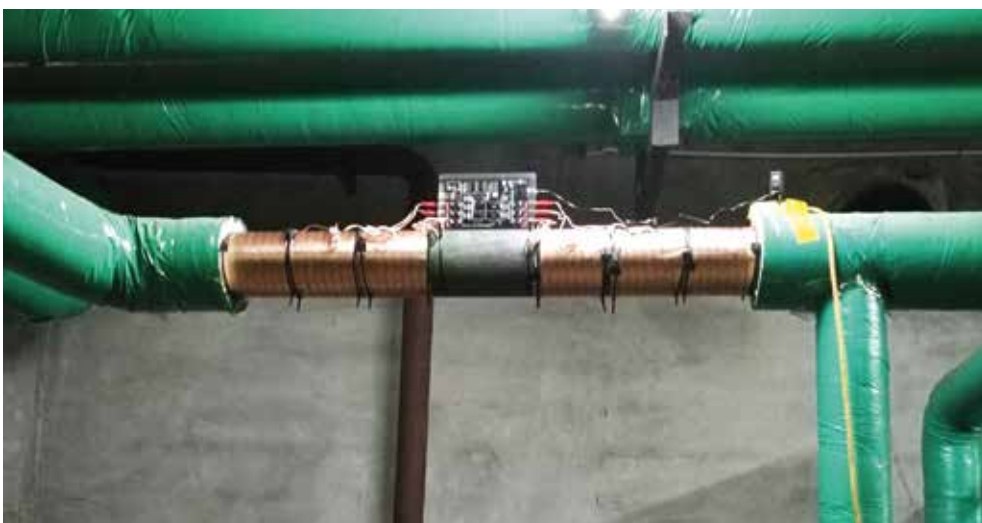
Vulcan S100 was installed on the main circulation water supply, which is from the municipal water.

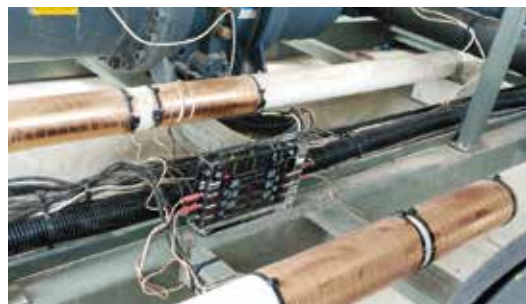
Vulcan S100 was installed on the main air-conditioning system

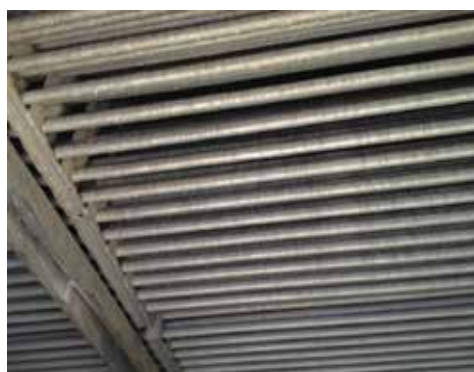
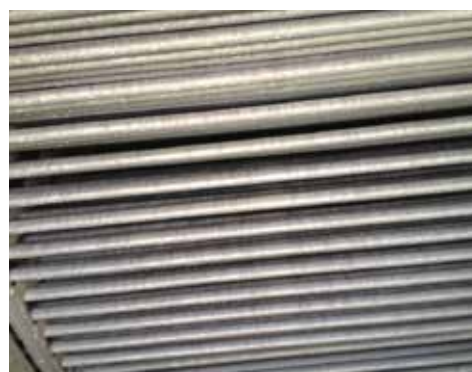
Clean cooling tower after using Vulcan

This picture was taken after 4 months the installation of the Vulcan S25. The tower was dirty/not cleaned before the Vulcan was installed.

Since the Vulcan installation, the cooling towers have been scale free and there has been no need for any chemical treatment.

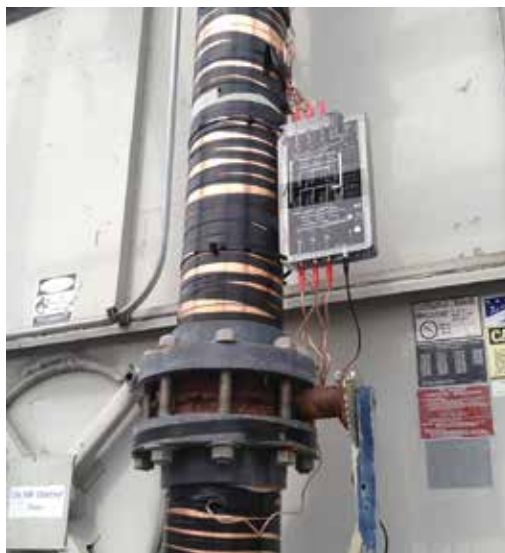
Vulcan S100 installed on cooling towers

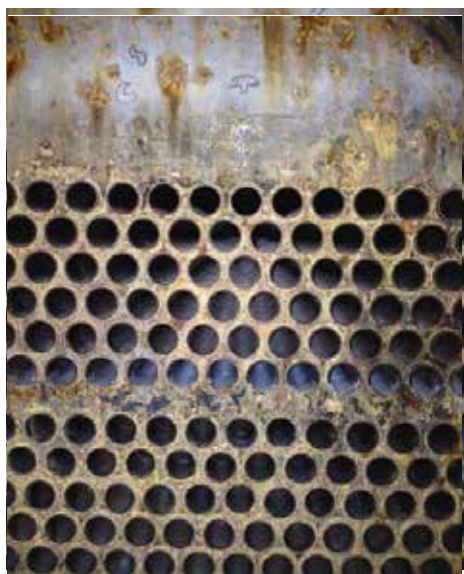
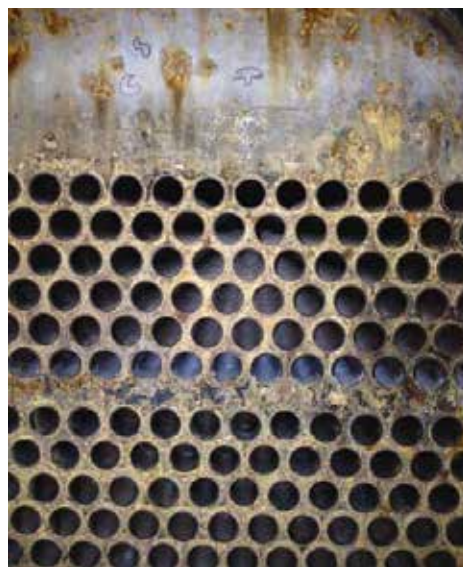
No scale formation after using Vulcan

Here are two pictures from a Chiller opened for a routine cleaning, but nothing to clean after two years with Vulcan treatment.

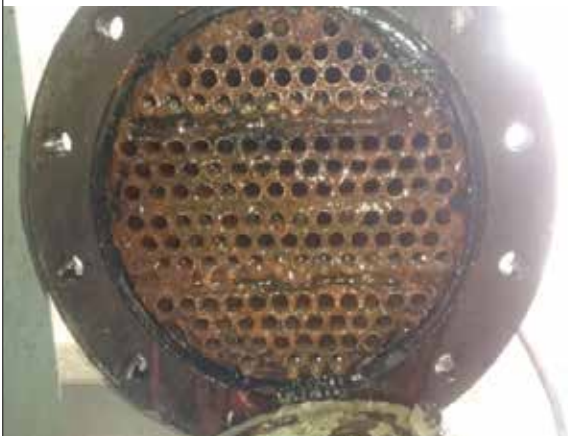
**Heat exchanger before Vulcan installation**

- scale deposits in oil heat exchanger
- oil temperature >50°C: very high
- to clean every month
- heat exchanger has corrosion
- scale deposits clog the pipe

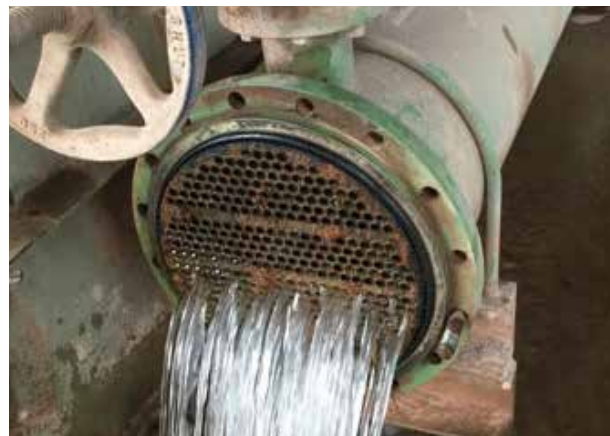
**Heat exchanger after 2 months Vulcan installation**

- oil heat exchanger is clean
- temperature is stable at 37°C – 40°C
- no need to stop machines to clean anymore
- save 7% electric energy at grinders

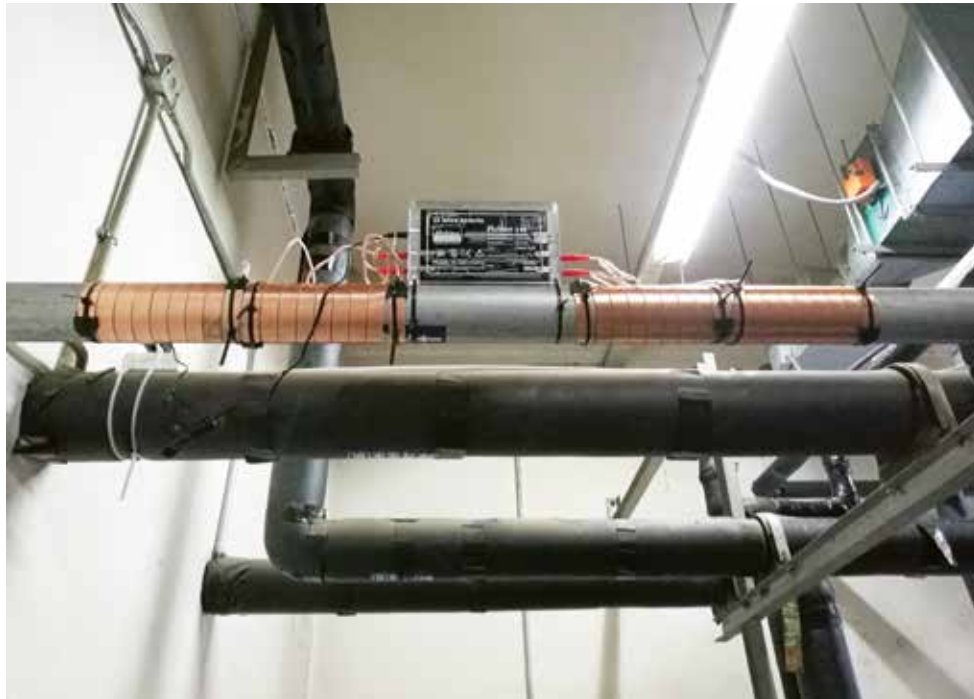
Vulcan S25 installed on the main water pipe of the cooling tower.

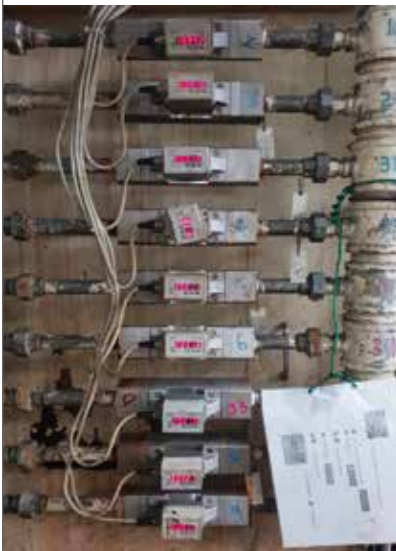
There are 9 secondary small pipes with water meters. These meters were installed to make sure a stable flow rate. If the flow rate goes down, it would cause a problem of the induction hardening machine. Therefore, the pipes had to be cleaned manually every 2-3 months.

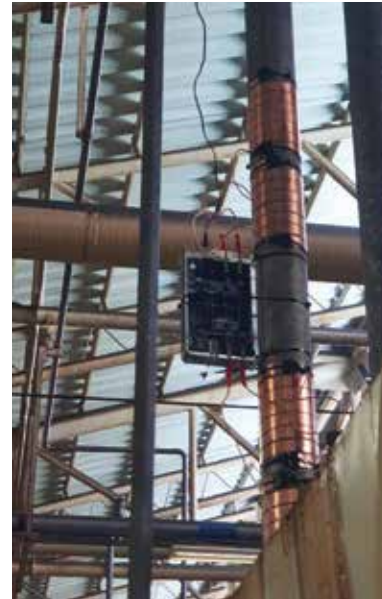
Vulcan S25 was installed around 50 meter before the induction hardening machine.

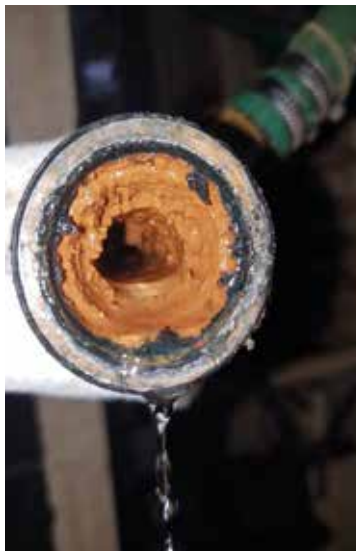
**First inspection:**  
May 21, 2018.

Inside of a secondary small pipe, before Vulcan S25 was installed.

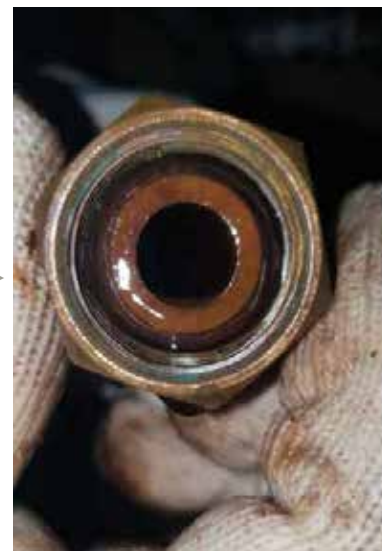
**Last inspection:**  
November 21, 2018.

After 6 months with Vulcan treatment: the pipe is free of scale.

2. After Vulcan S25 had been installed for 6 months, the secondary pipes were opened: scale that had been left in piping had disappeared and all 9 secondary pipes had become clean (see photo).

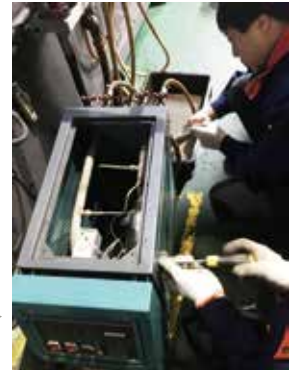
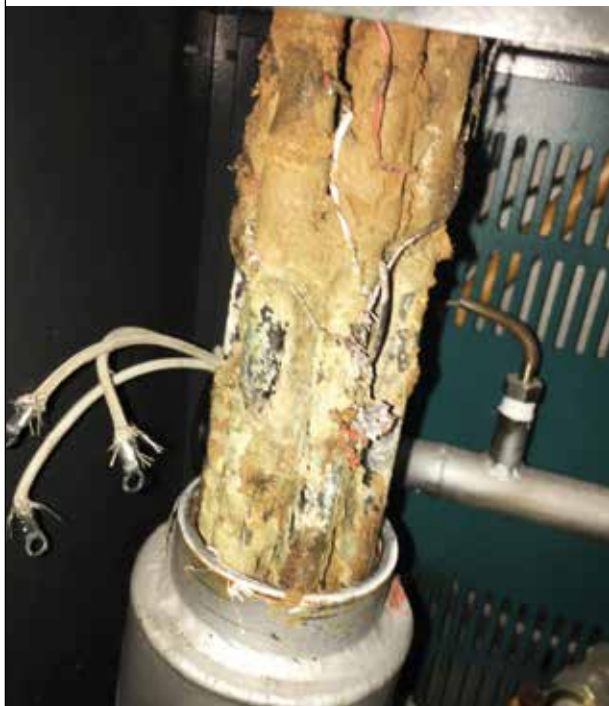
Untreated heat exchanger for 3 years.

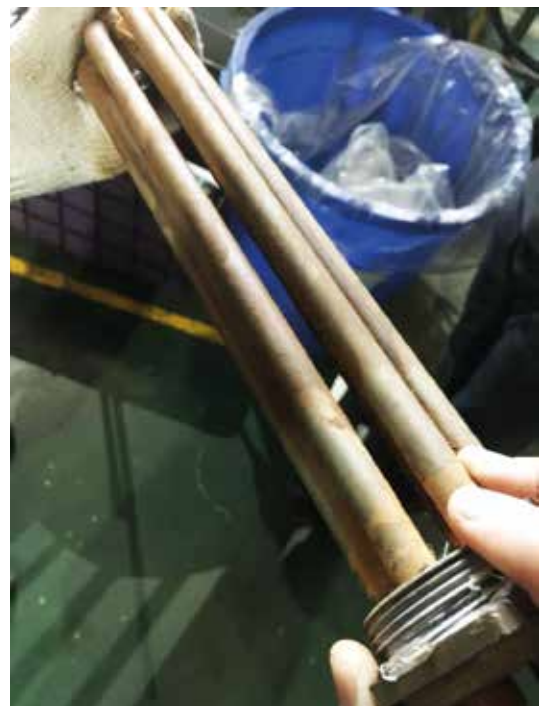
After installing Vulcan for 1.5 years, the scale is gone without extra cleaning.

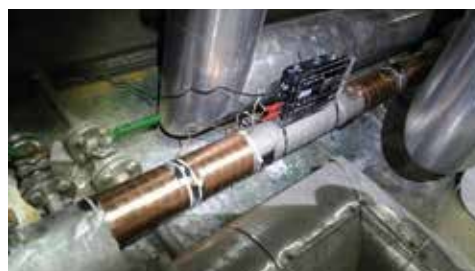
Vulcan S25 installed at Toray Industries

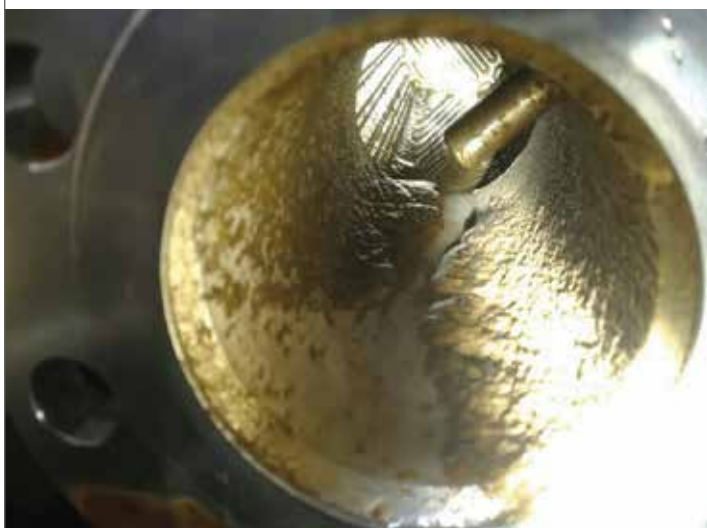
Before – without Vulcan

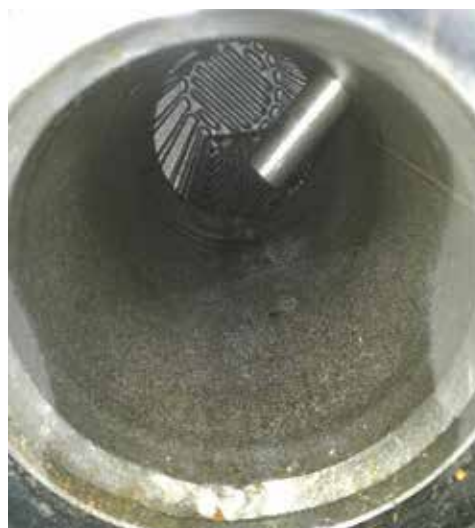
After 3 months – with Vulcan treatment.  
Up to now the installed pipe line needed no cleaning.

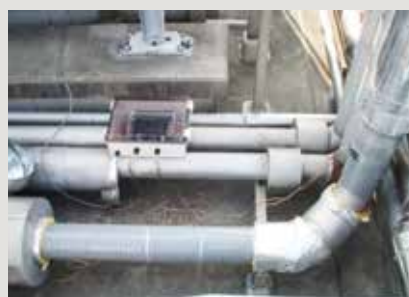
Vulcan S100 installation

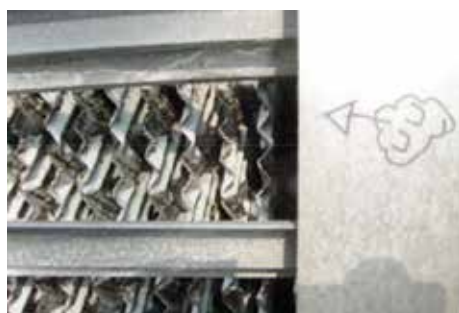
Before Vulcan was installed: the outside of the cooling tower.

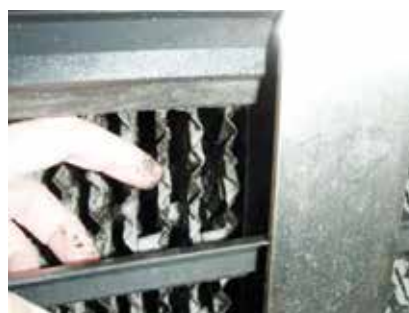
After Vulcan was installed for 5 months: the scale can be removed easily with a finger.

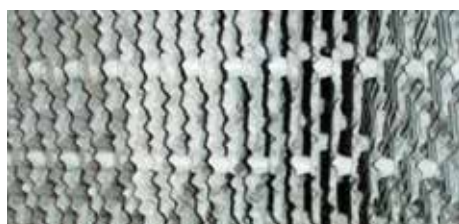
Before Vulcan was installed: the inside of the cooling tower.

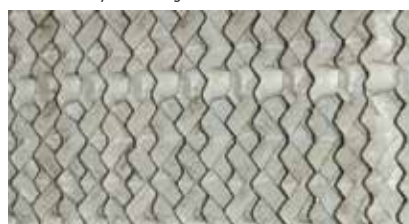
After Vulcan was installed for 5 months: the scale has been reduced.

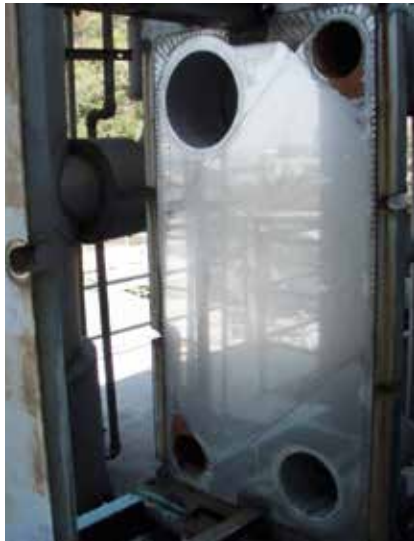
After Vulcan was installed for 9 months: ready open the plate heat exchanger and clean.

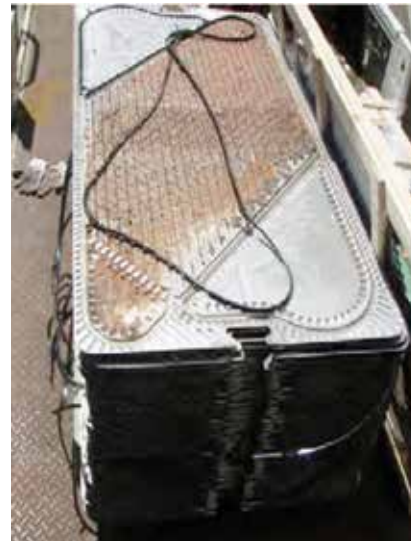
After Vulcan was installed for 9 months: the plate heat exchanger was taken apart for cleaning.

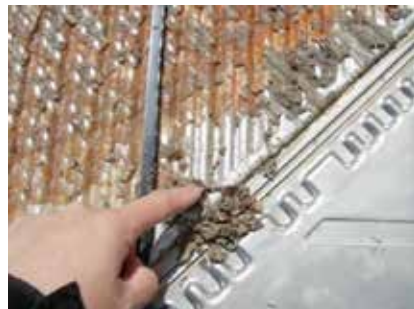
The scale on the plate heat exchanger becomes soft.

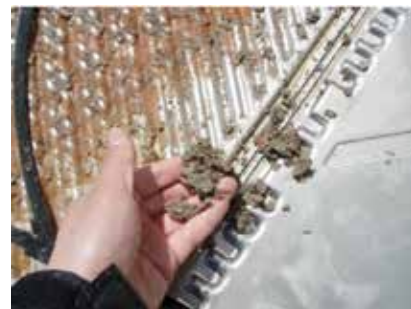
The scale can be easily removed.

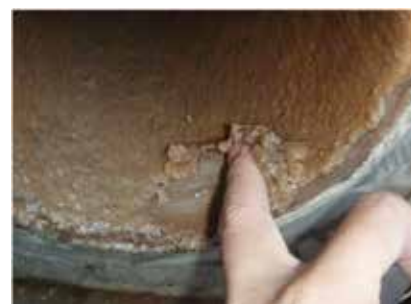
The scale in the circulation pipe can also be easily removed with a finger.

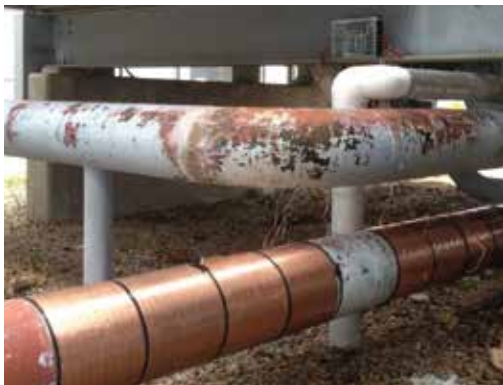
Vulcan S250 installed on a 10 inch diameter line that feeds twin cooling towers (CT-1 and CT-2)

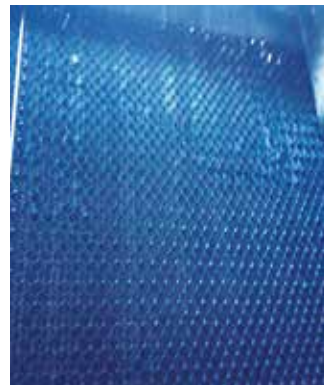
This photo was taken of the inside of CT-1.

It illustrates clean flutes that are in constant contact with Vulcan-treated water and a few dry (untreated) areas that still have some remaining green biofilm.

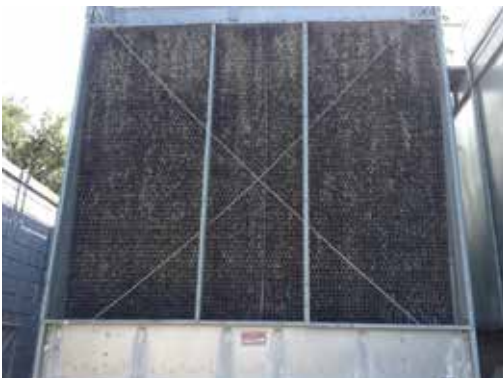
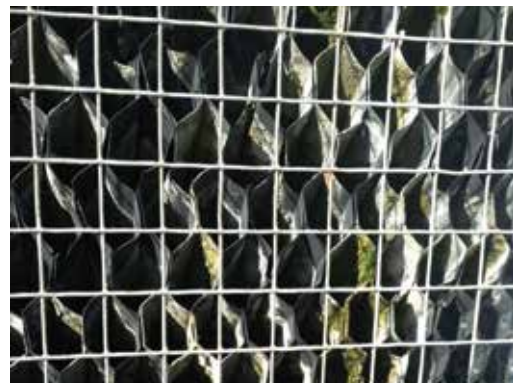
The photographs above were taken of CT-1 about 3 weeks after the Vulcan was installed.

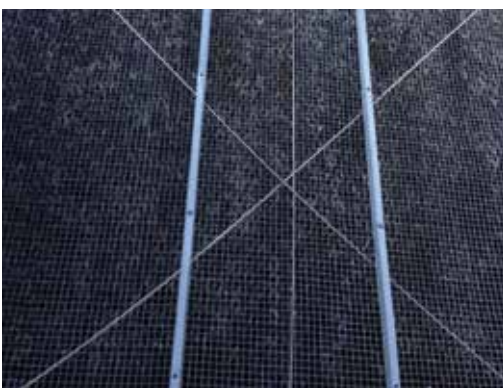
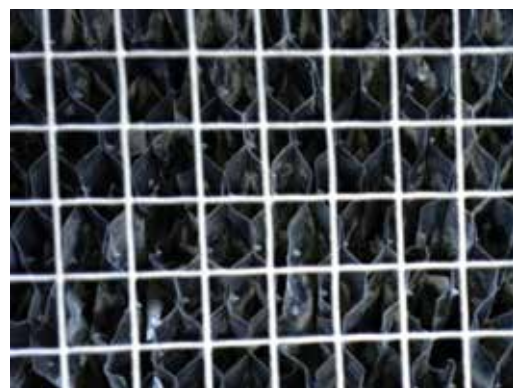
These photos were taken of CT-1 after about 6 weeks.
